# Final Commissioning Report For Eastmont High School

October 2015

# Appendix A – Field & Commissioning Issues Reports

### EASTMONT HIGH SCHOOL COMMISSIONING ISSUES

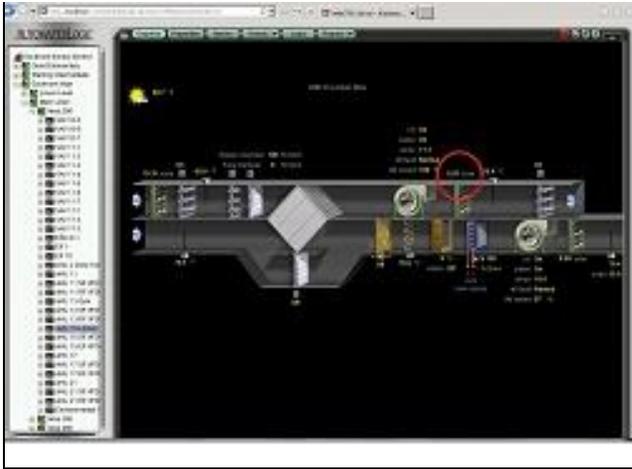
ID	Summary	Proposed Resolution	Actual Resolution	Date resolved
M-01	<p><b>08.26.13--</b> During functional performance testing, CSG noted the air flow measuring station for the return fan of AHU-15 was non-operational and still required factory calibration. Bruce HVAC needs to provide documentation of the air flow measuring station calibration. If they came factory set, they need to engage a factory rep to visit the site to recalibrate them, and together with the TAB report, ensure all airflow documented and being reported are similar.</p>	<p>Bruce HVAC was in the process of scheduling the factory to calibrate them. We recommend they confer with the TAB contractor to ensure the flow stations are reading accurately and closely match the airflows the TAB contractor has measured. The flow station sampling tubes aren't always placed in a cross-sectional manner so that a better average of velocities are measured and we have noted on several occasions where they are simply not very accurate unless the TAB contractor is able to assist or the TAB report is referenced as well.</p>	<p>Although CSG has verified the outside air, supply air and exhaust air flow stations are indeed now providing a readout, we do not believe they are doing so accurately. Because this issue solely revolves around the sensors functionality, we have agreed to close it. However, an additional Issue ID has been created to track the corrective measures taken to ensure all data being reported is done so accurately and within design parameters.</p>	11.20.13

Issue ID #M-01 –Bad Air Flow Sensor

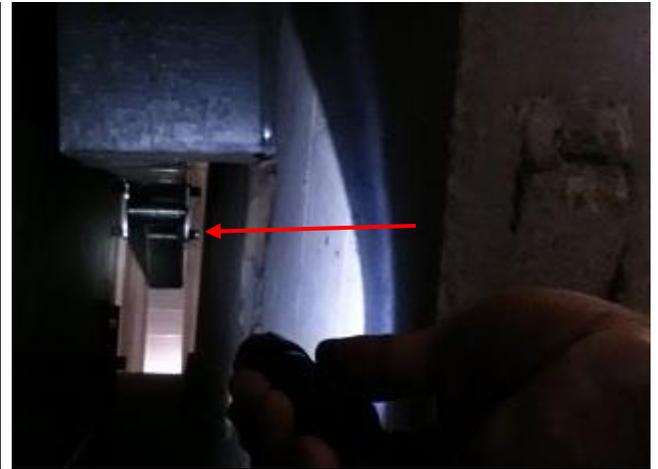
M-05	<p>100 Area-Existing EF-1 ductwork has a large opening in the main duct, causing excessive leakage.</p> <p><b>04.15.14--</b> CCA # 33, in response to RFI 732 has been issued with proper direction for sealing the ductwork as best as possible considering its location within an existing shaft that is to remain.</p> <p><b>08.26.13--</b> During balancing verification, the TAB contractor showed us why the airflow at EF-1 was only providing roughly 50% of design airflow. There is a large section of missing ductwork in the existing main that needs to be repaired and sealed. Without repair, there is no other way to ensure adequate ventilation is being provided to those spaces EF-1 serves.</p>	<p>ALSC and MSI should review the conditions of the existing section of ductwork to determine the best course of action in making sure the system as designed can perform adequately to serve the spaces ventilation requirements.</p>	<p>Brad Snow with MSI was asked for his opinion on the state of the laundry room exhaust system and stated he did not believe the lack of full volume of exhaust air from the laundry room would have a negative effect on the building. The airflows being reported are accepted as is.</p> <p><b>08.19.14-</b> Bruce has stated they have patched the ductwork per CCA #33. CSG verified airflow quantities have increased.</p> <p><b>11.20.13--</b> Presently, there is a change order out for review to repair or patch the existing ductwork. Access into the chase is severely limited and a final course of action has yet to be adopted by contractors or the designers.</p>	09.30.14

Issue ID # M-05—Exhaust duct is open

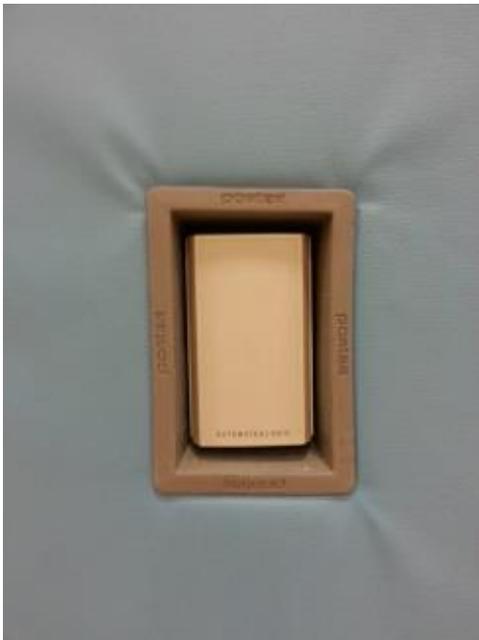
Issue ID #M-08—T-stat reading +4°F

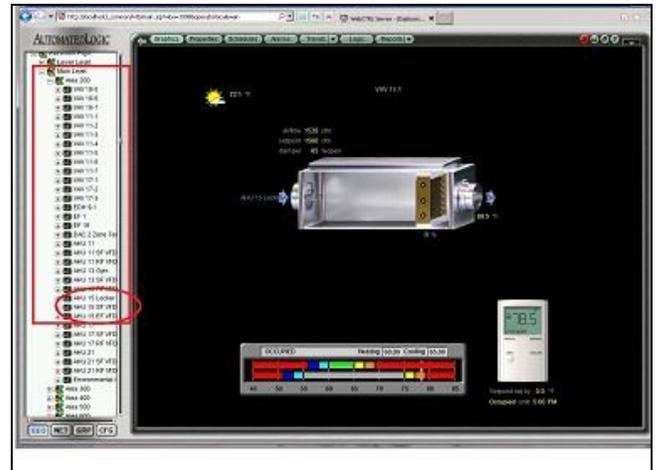
Issue ID #M-013—Equipment Tree

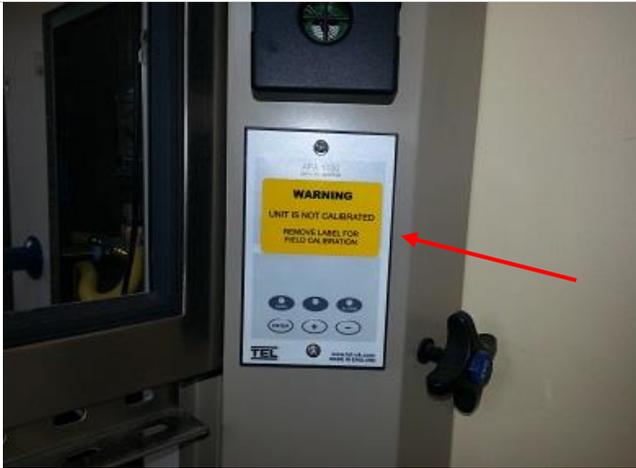
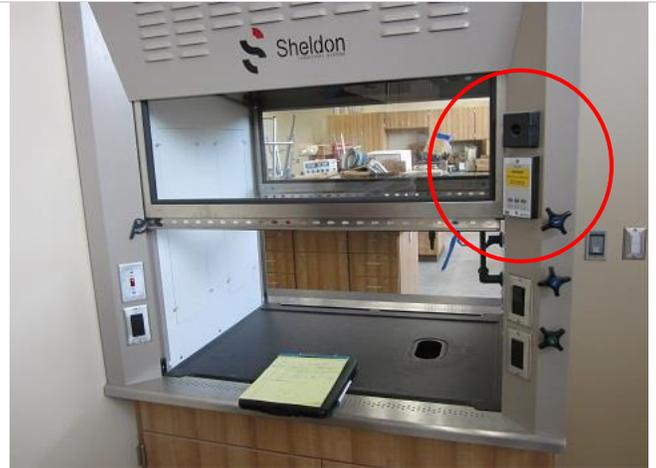
ID	Summary	Proposed Resolution	Actual Resolution	Date resolved
M-19 Cont'd	<p><b>The Lab Fume Hoods are not functioning as designed.</b></p> <p><b>08.26.13--</b> During functional performance testing, we noted several exhaust fume hoods located in the Science classrooms did not have their accompanying alarm modules calibrated as they still had the factory stickers on them. Typically, they must be field calibrated to alarm once the velocity drops below a prescribed volume of air across the sash opening. This allows an end user to access whether adequate airflow is present to continue using the fume hood safely. These modules cannot come factory calibrated as variables with airflows may exist in the field that cannot be duplicated at the factory such as fan speeds, ductwork configuration and leakage tolerances.</p>	<p><b>Continued:</b></p> <p><b>11.25.13--</b> Petra stated they were reviewing the specifications to determine whether the manufacturer is responsible for any wiring or calibration of the local audible alarm modules or whether they or their subs do. They will provide clarification.</p>	<p><b>Continued:</b></p> <p><b>06.26.14--</b> Gary Holland stated the following per email; "Steven--Our fume hood monitors can be wired such that they will power off when another switch they are connected to is also turned off. Typically this would be the hood's fan switch. If the 500's power is connected to an "on 24/7" outlet, the 500 would never be turned off and would go into alarm whenever the airflow goes below the alarm point."</p>	10.02.14

Issue ID #M-19—Fume Hood Alarm’s are not powered or available to provide an audible alarm to an end user in case of airflow failure across the hood sash.

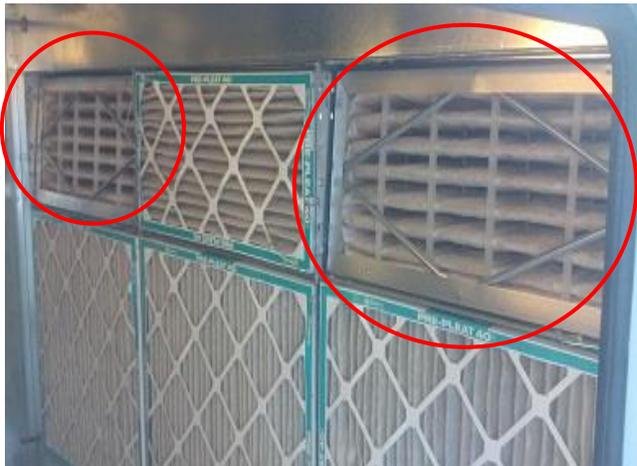
ID	Summary	Proposed Resolution	Actual Resolution	Date resolved
M-23	<b>08.26.13--</b> During functional performance testing, we noted two pre-filters were missing from the bank within AHU-14. The result is prematurely loading the more expensive final filters and lowering the useful life of the filter, requiring change out sooner than most.	Bruce HVAC should ensure all final filters are in place and document all future changes as required in the specifications.	<b>10.16.13--</b> Bruce HVAC has notified us they have installed the missing filters. CSG verified they were installed during our November site visit.	11.20.13
P-24	<b>08.26.13--</b> Several roof drains did not yet have the basket strainers installed and several were filled with construction debris and garbage. If there are any clogged downspouts, this is likely a good reason.	Contractors should complete installation and clean up all surrounding debris before the rainy season begins.	<b>10.16.13--</b> JRT Mechanical has notified us the basket strainers have all been installed and are free from debris inhibiting flow. This was verified during our November site visit.	11.20.13

Issue ID #M-23—Missing Filters—AHU-14

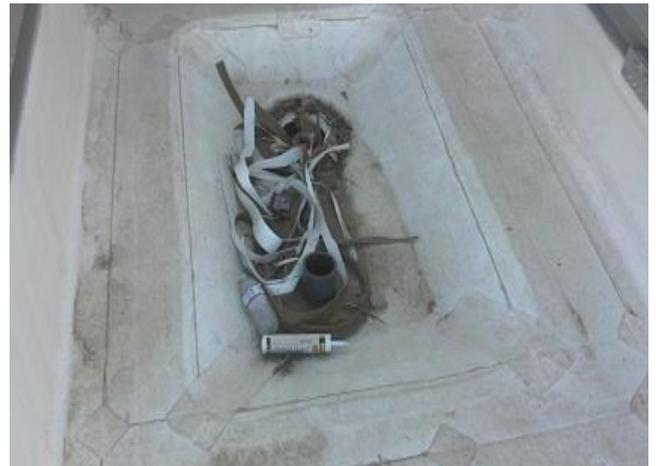
Issue ID #P-24—Roof Drains

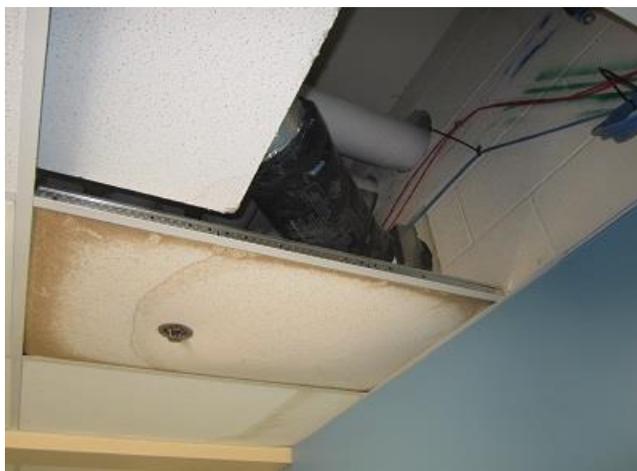
Issue ID #P-32—Leak above ceiling

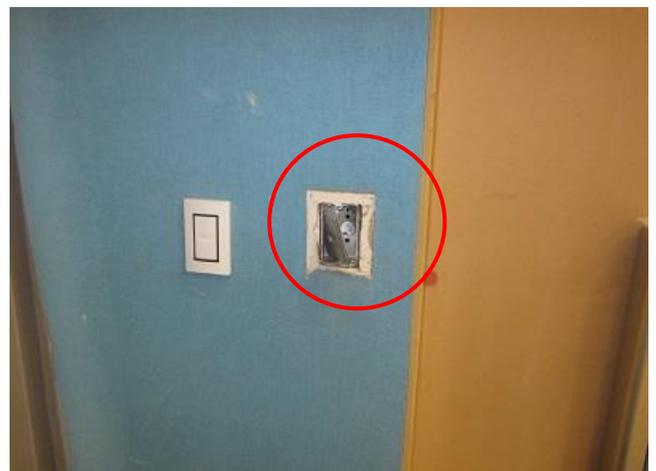
Issue ID #P-43 & 44—Area 100 open boxes

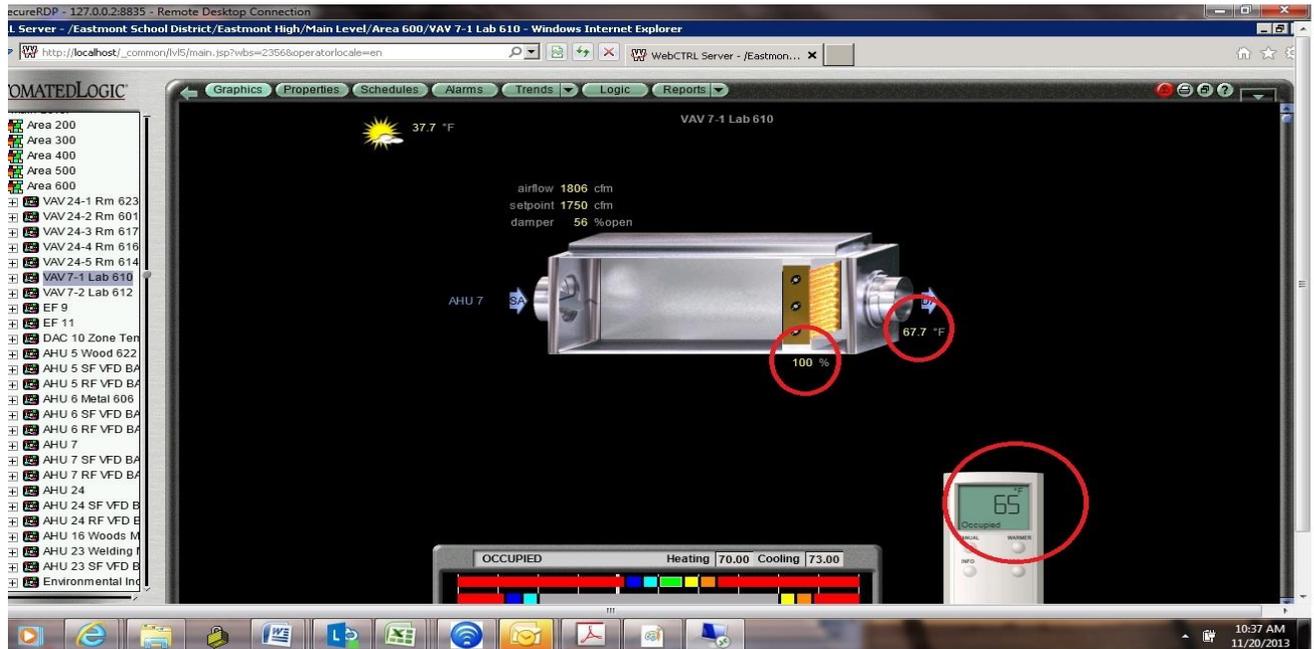
Issue ID #M-58—Electric heater not working. With 100% command, DAT = 67.7°F.

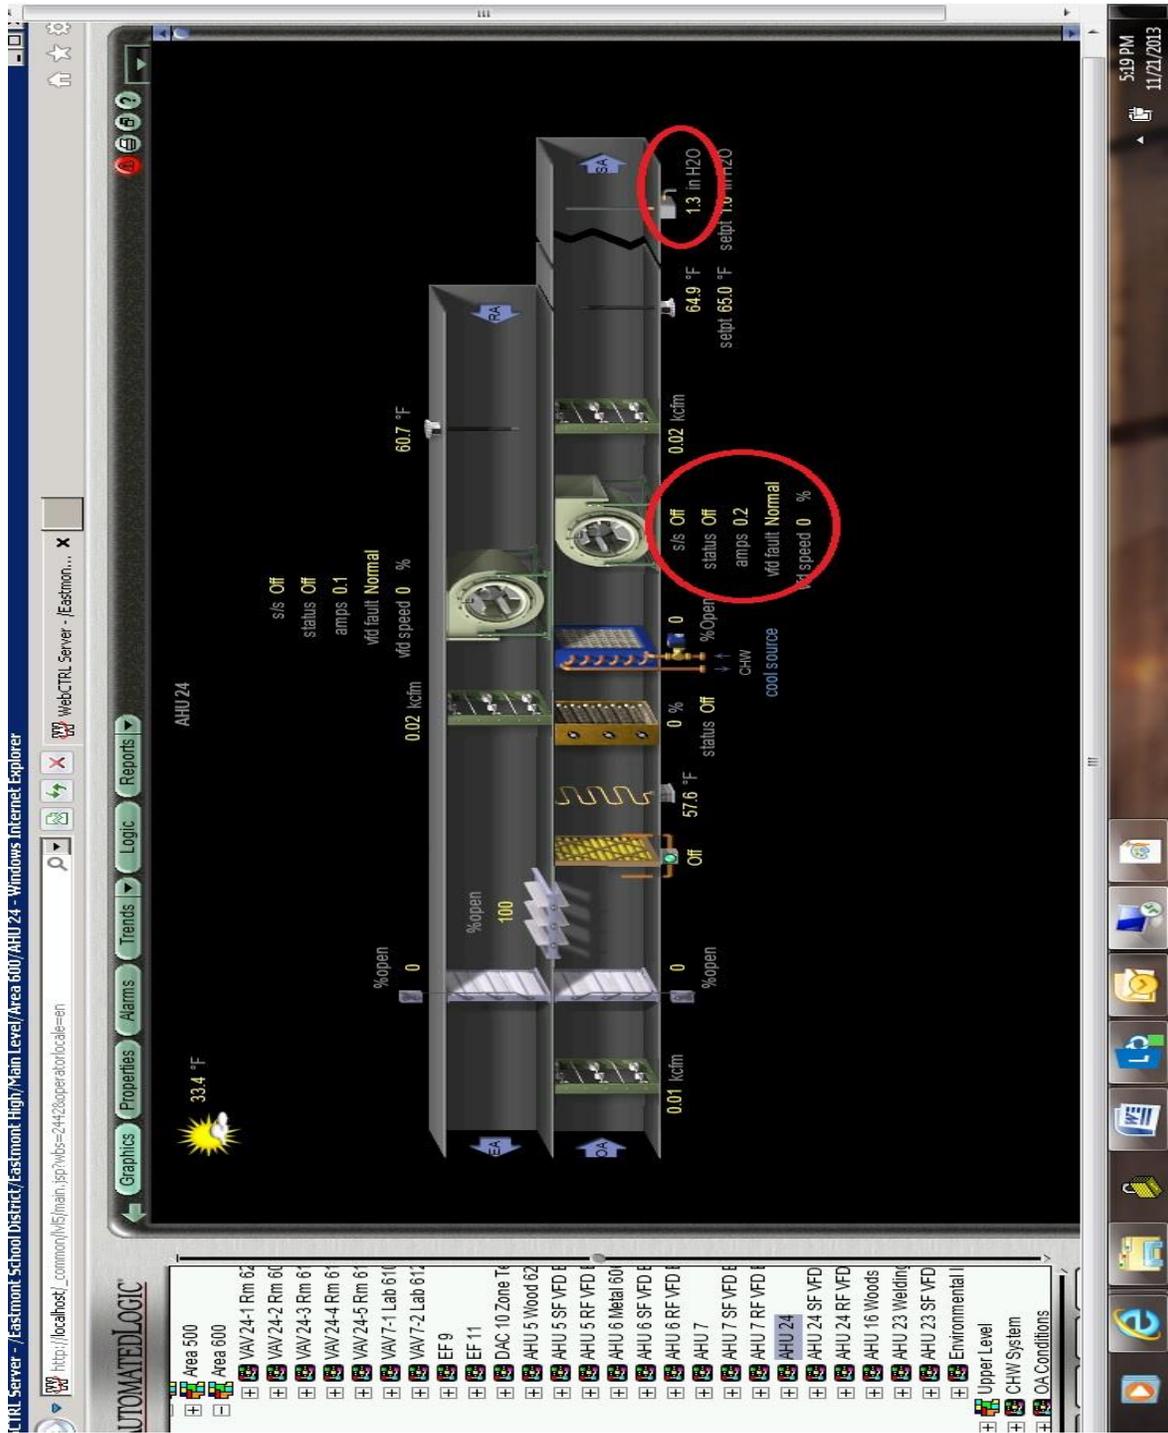
Issue ID #M-069—Although all fans are off, the static pressure within the duct is still being reported at 1.3”.

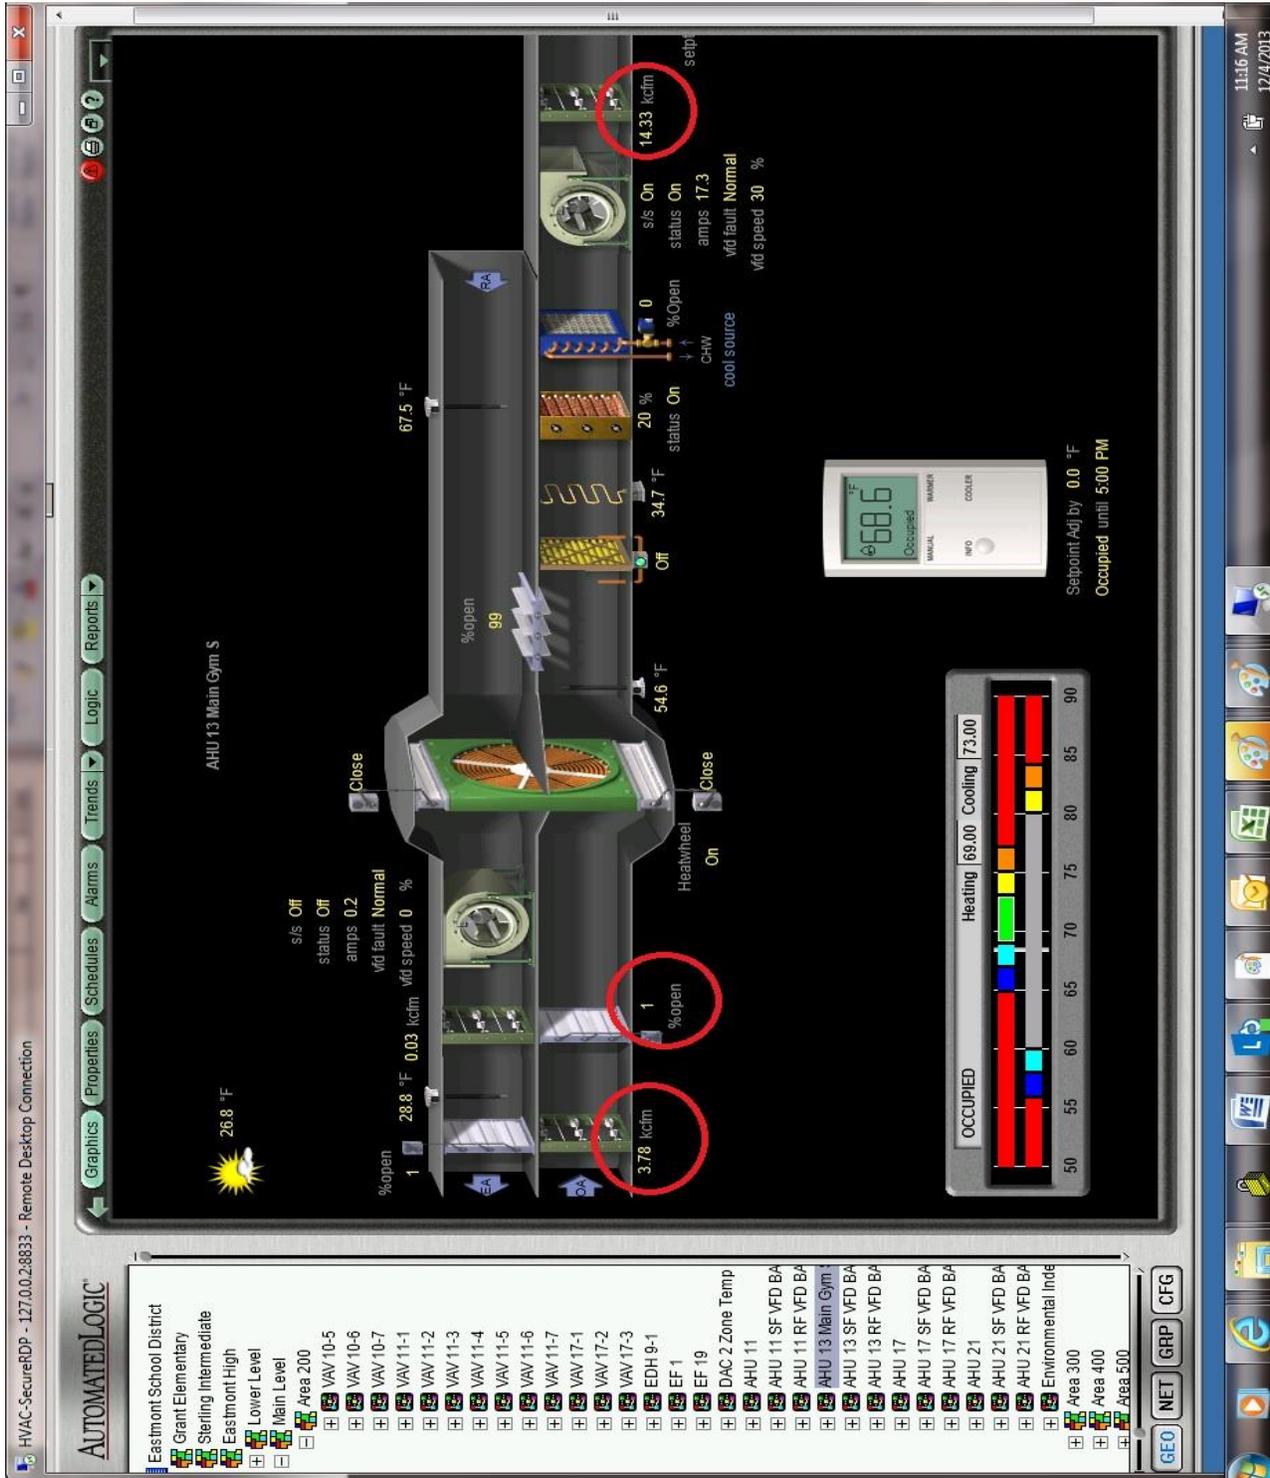
Issue ID #M-072—Airflow stations not measuring accurately. The supply air reading surpasses both design air for the unit as well as what’s reported in the TAB report. With OSA damper essentially closed, there should not be 3780 CFM at the flow sensor.

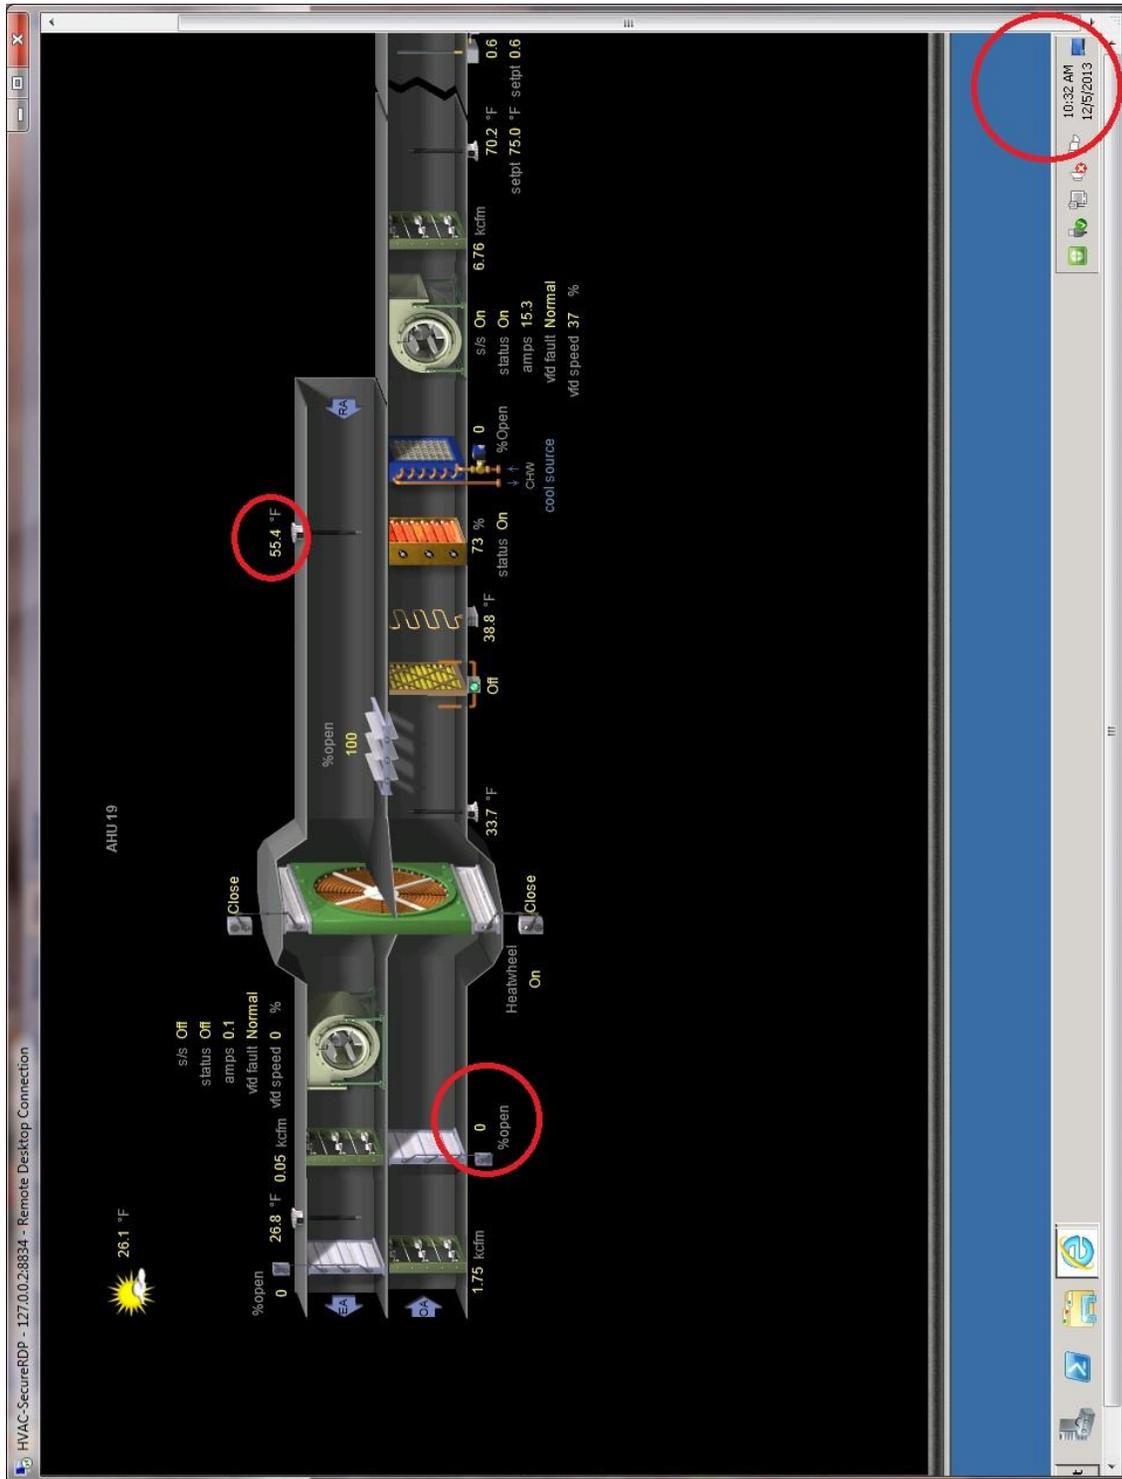
Issue ID #M-078— At 10:30 AM, the return air temperature from the space is only at 55.4°F indicating the space temps are extremely low throughout the entire 700/800 Areas. Of even more concern is the lack of ventilation air to occupied spaces because the lack of space temps keeping the AHU in Morning Warm up mode. Both issues violate WAC requirements for schools.

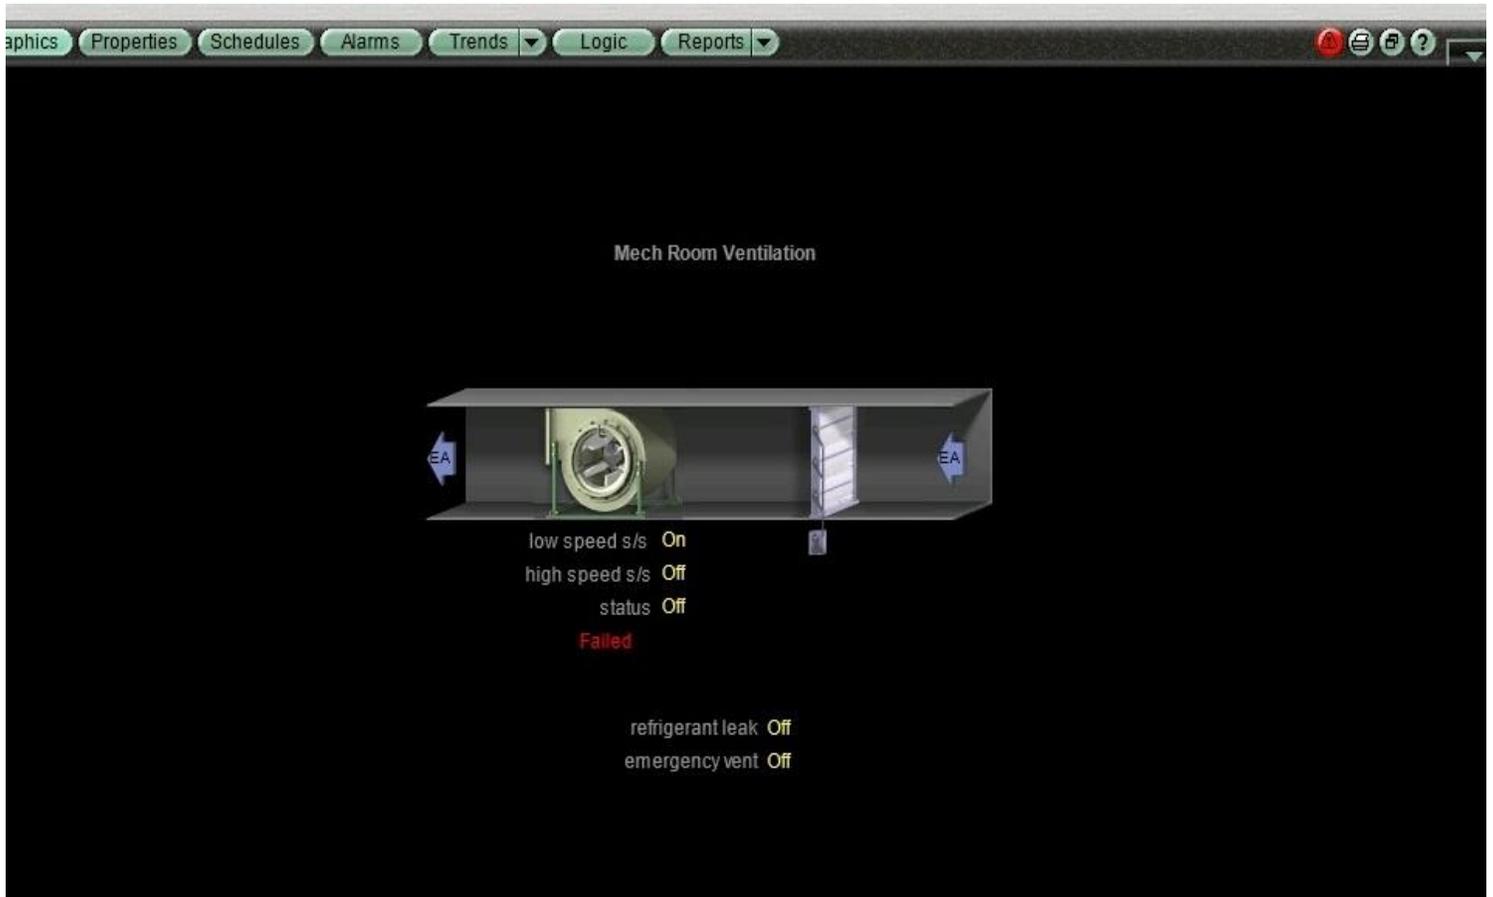
Issue ID #M-97—EF-18 has a failure. Commanded to run but is not capable.

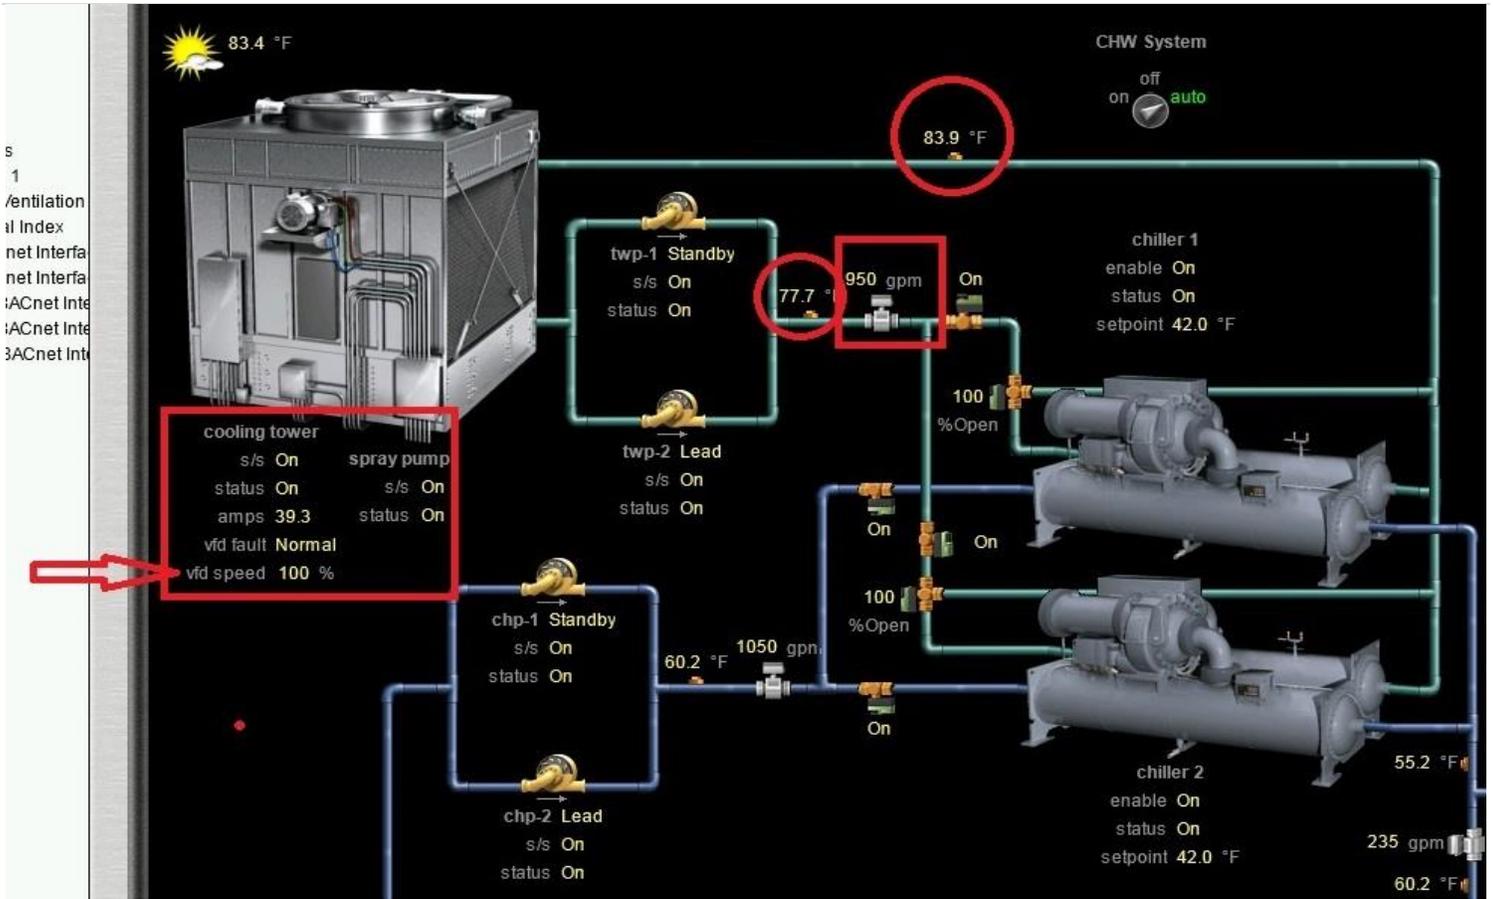
Issue ID #M-98—Cooling tower performance does not appear to match the manufacturer’s performance data. A 6°F delta T at 100% capacity at only 83°F ambient temperatures seems low. The flow rate does not match the design. It is unknown what the wet bulb temperature is, what the air flow and spray water flow is at this time but that data should be provided in order to determine why it is underperforming. The design indicates a delta T of 10°F with a leaving fluid temp of 85.5°F. Here, the entering fluid temp isn’t even 84°F. It seems as though this system is wasting energy by operating at 100% capacity to get a 6°F delta T with entering and leaving fluid temps below the design. The cooling tower loops requires additional tuning to provide the most efficiency.

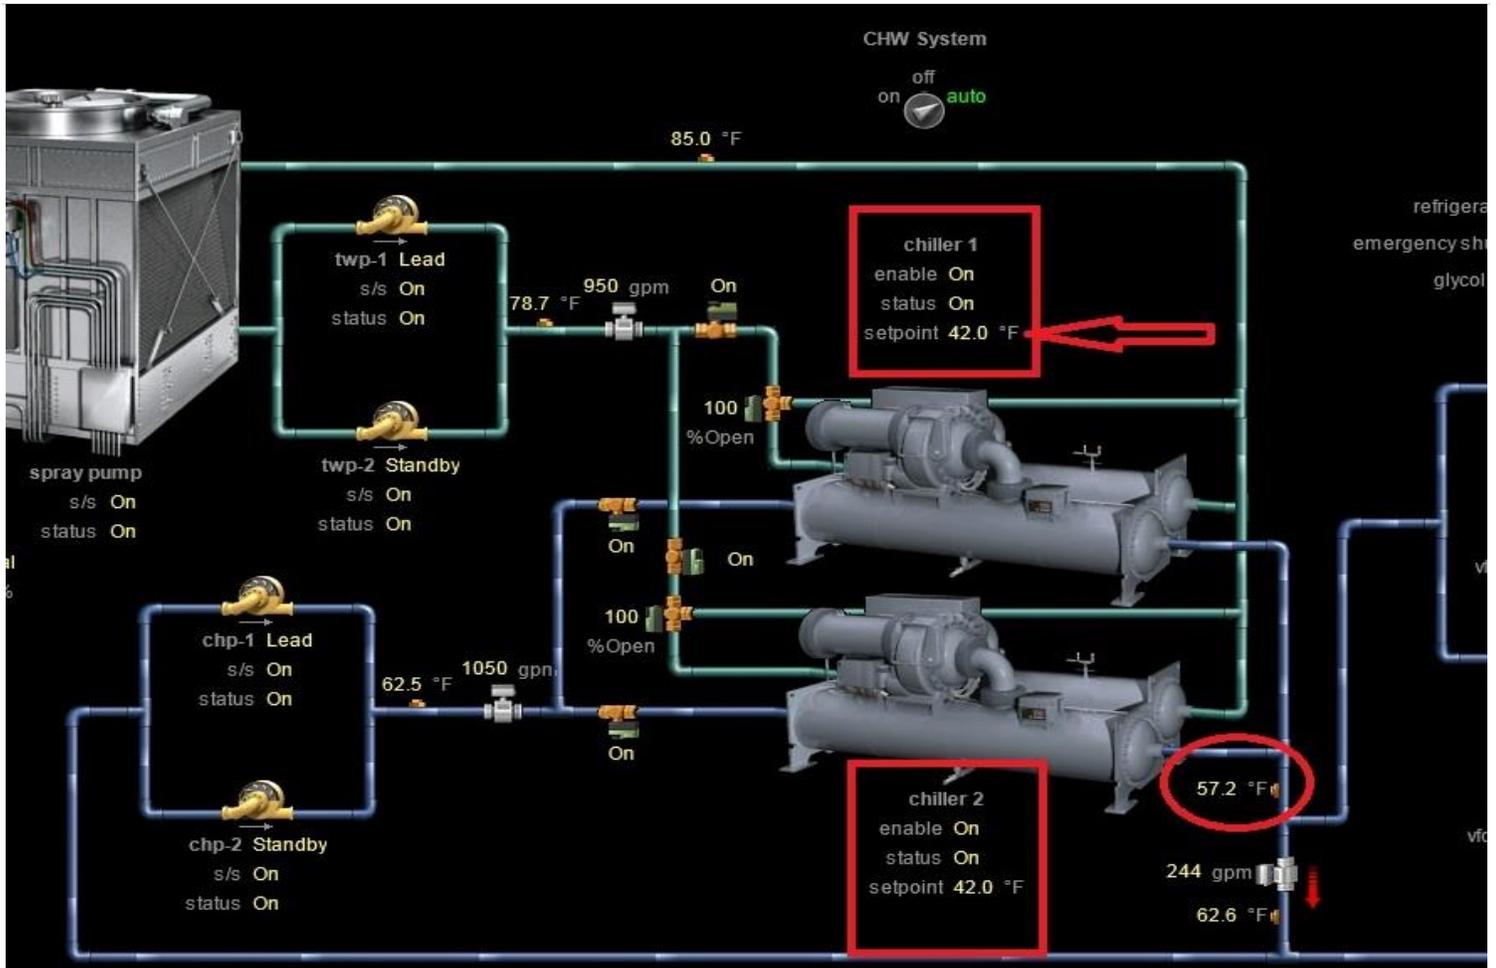
Issue ID #M-99—the chilled water loop temperature is unable to meet the set point of 42°F. Even with both chillers operating, the leaving water temperature is only 57.2°F and slightly warmer in the actual secondary loop after the circulation pumps. Because the Bacnet interface for both chillers is not yet completed, we are unable to determine whether the chillers were operating at full capacity. But in either case, there appears to be an issue that it is operating at 15°F above the loop set point. None of the AHU's are able to meet their respective discharge air temperature set points either and are operating with their CW control valves wide open. I am unable to access trends at the moment, but reviewing operations for the previous 4 days indicates the system has yet to meet the loop setpoint at all. In the diagram below, note the loop temperature is up to 66.2°F which offers very little cooling capacity.

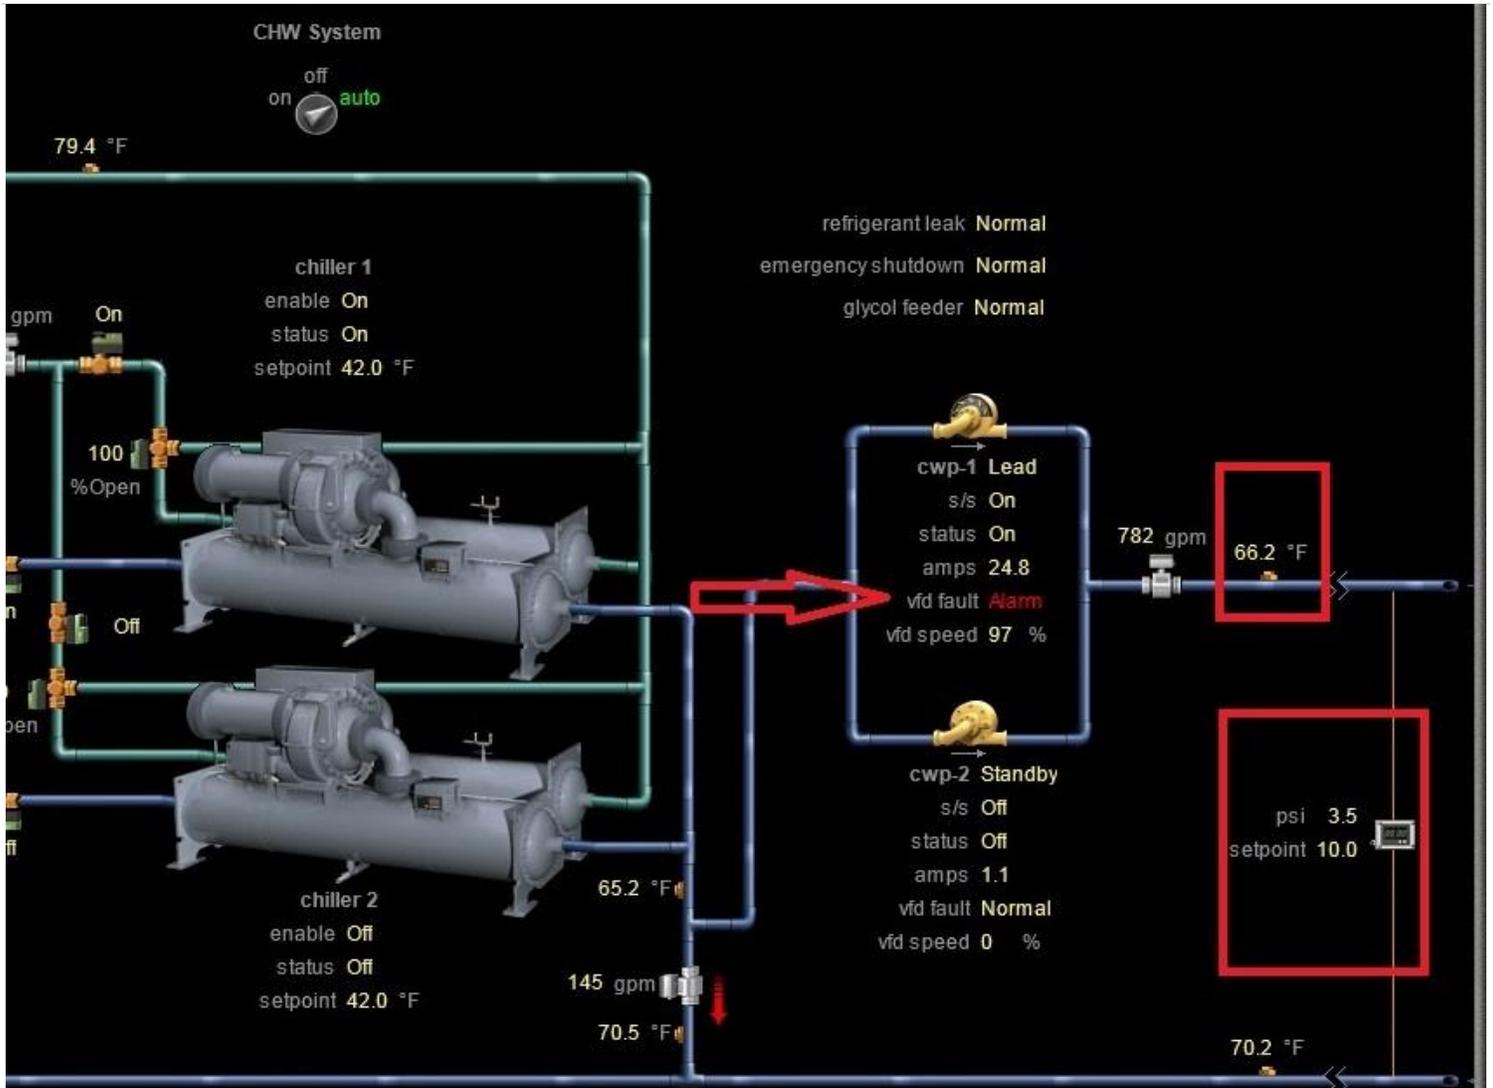
Issue ID #M-100—The CWP-1 VFD is in alarm. The CW loop differential pressure set point is not being met. Here the dP is 3.5 psi with a set point of 10 psi. CWP-2 is still on standby and should be cycling on to help increase water flow. Runtime is significantly higher for CWP-1 indicating lead / lag operation may not be working correctly. Trend data is not accessible at this time.

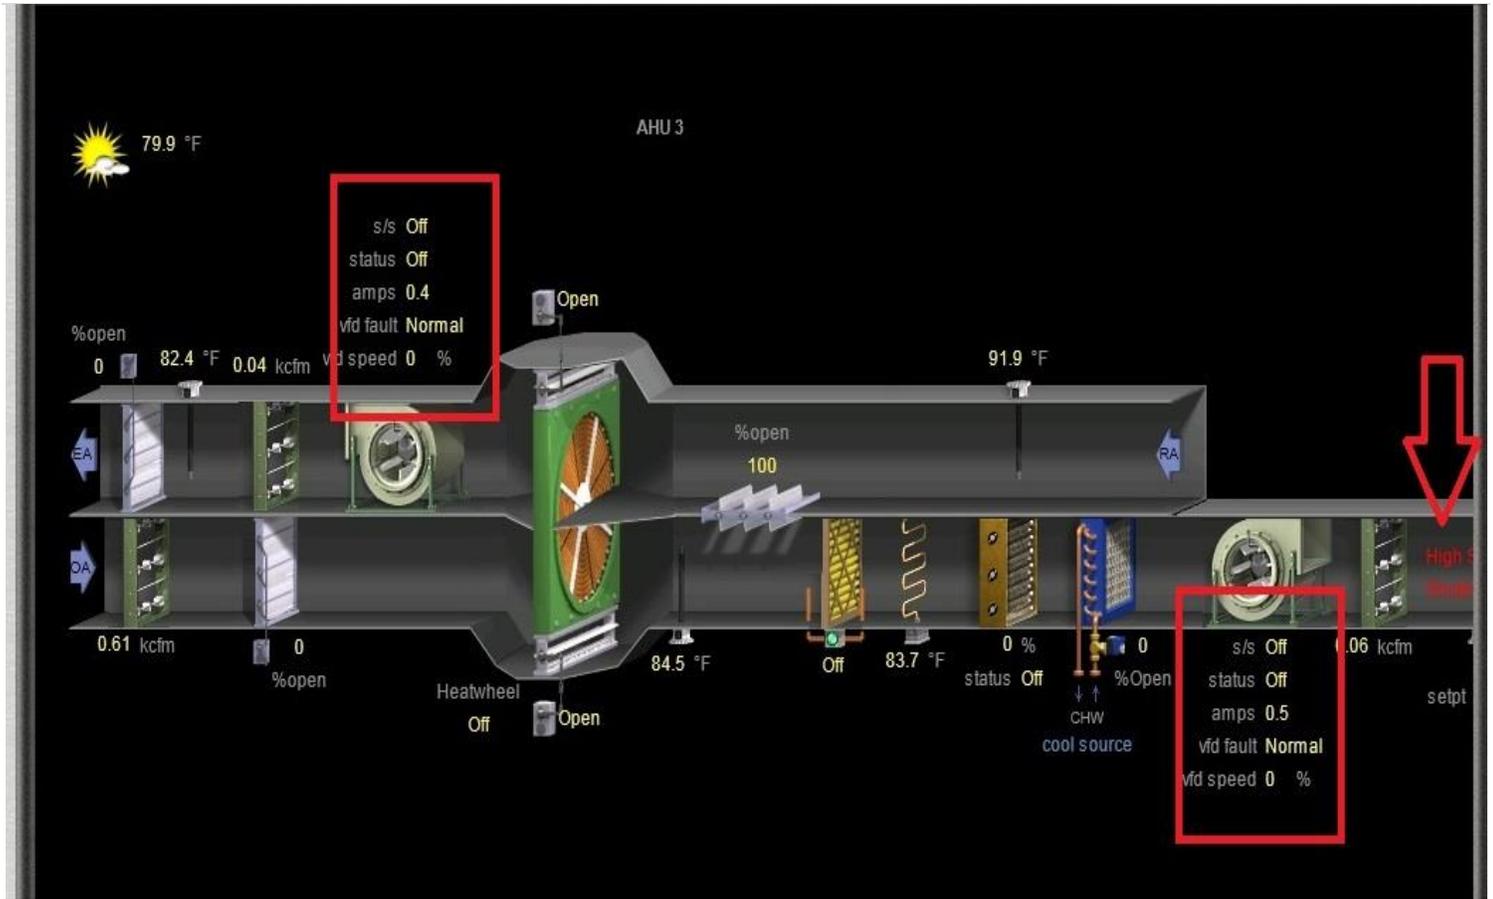
Issue ID #M-104—AHU-3 has failed and there is an unidentifiable alarm indicated towards a portion of the graphic that is not accessible. There is no way to scroll over in order to view it. Contractors should investigate and report back what findings there are prior to additional onsite Cx testing. Graphic should be so that it can be seen in its entirety.

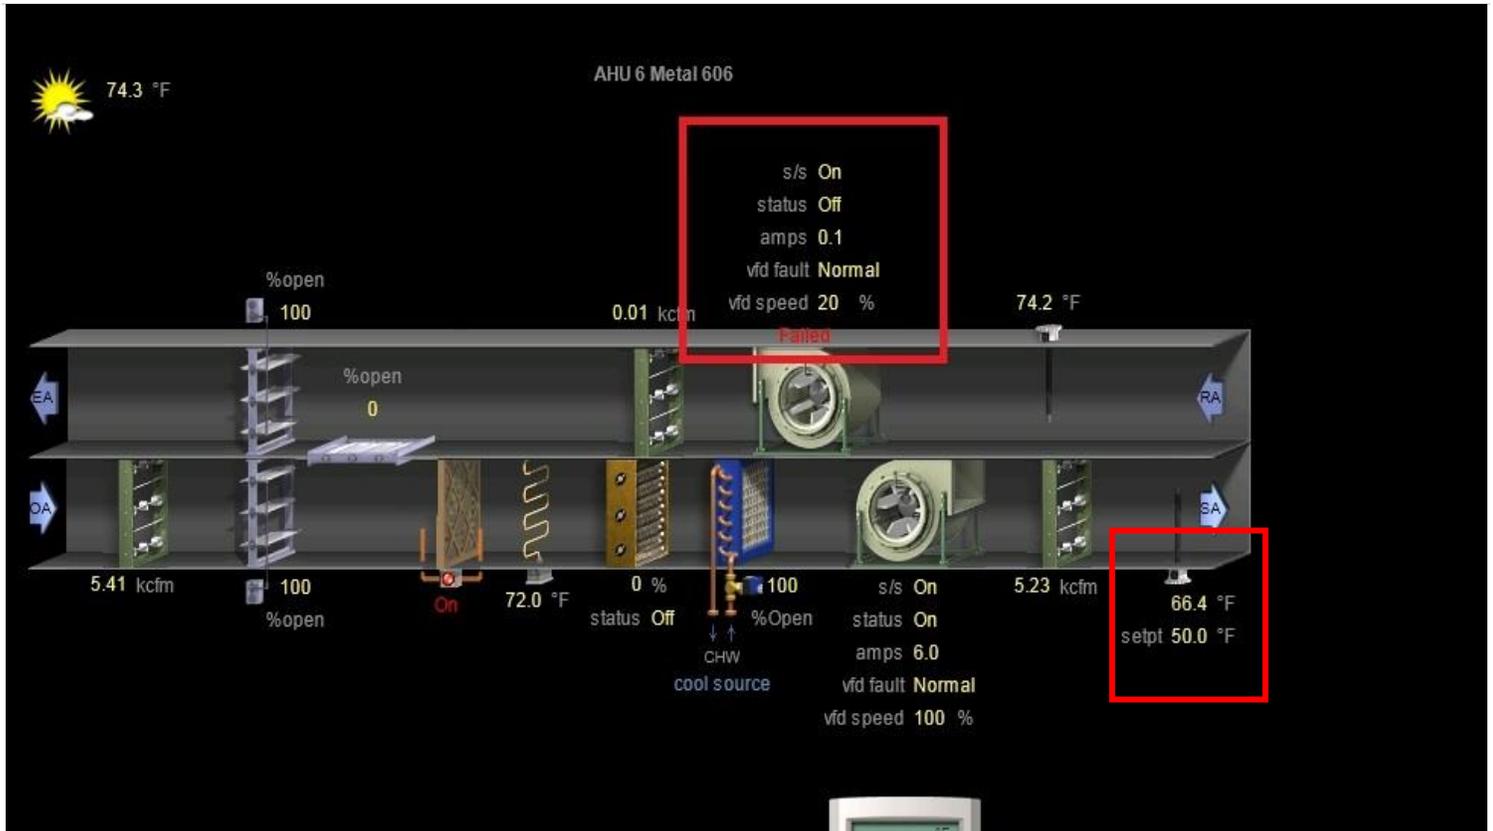
Issue ID #M-105—AHU-6 Return Fan has failed. Contractors should investigate and report back what findings there are prior to additional onsite Cx testing. Notice discharge air temperature with CW control valve wide open which is related to the concerns over the chilled water loop temperature.

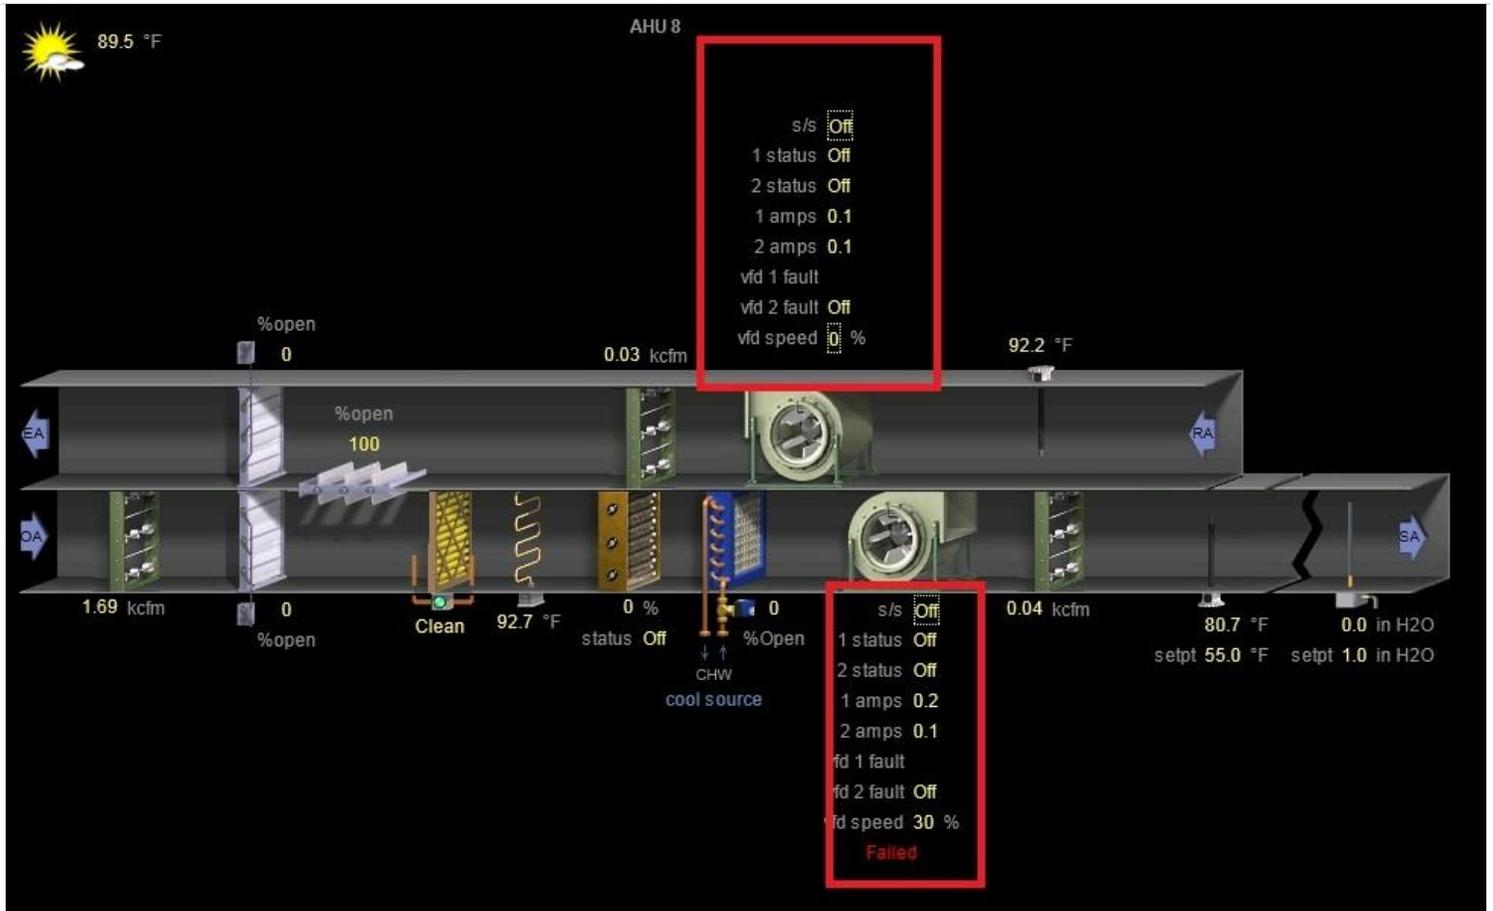
Issue ID #M-106—AHU-8 has failed and been overridden off.

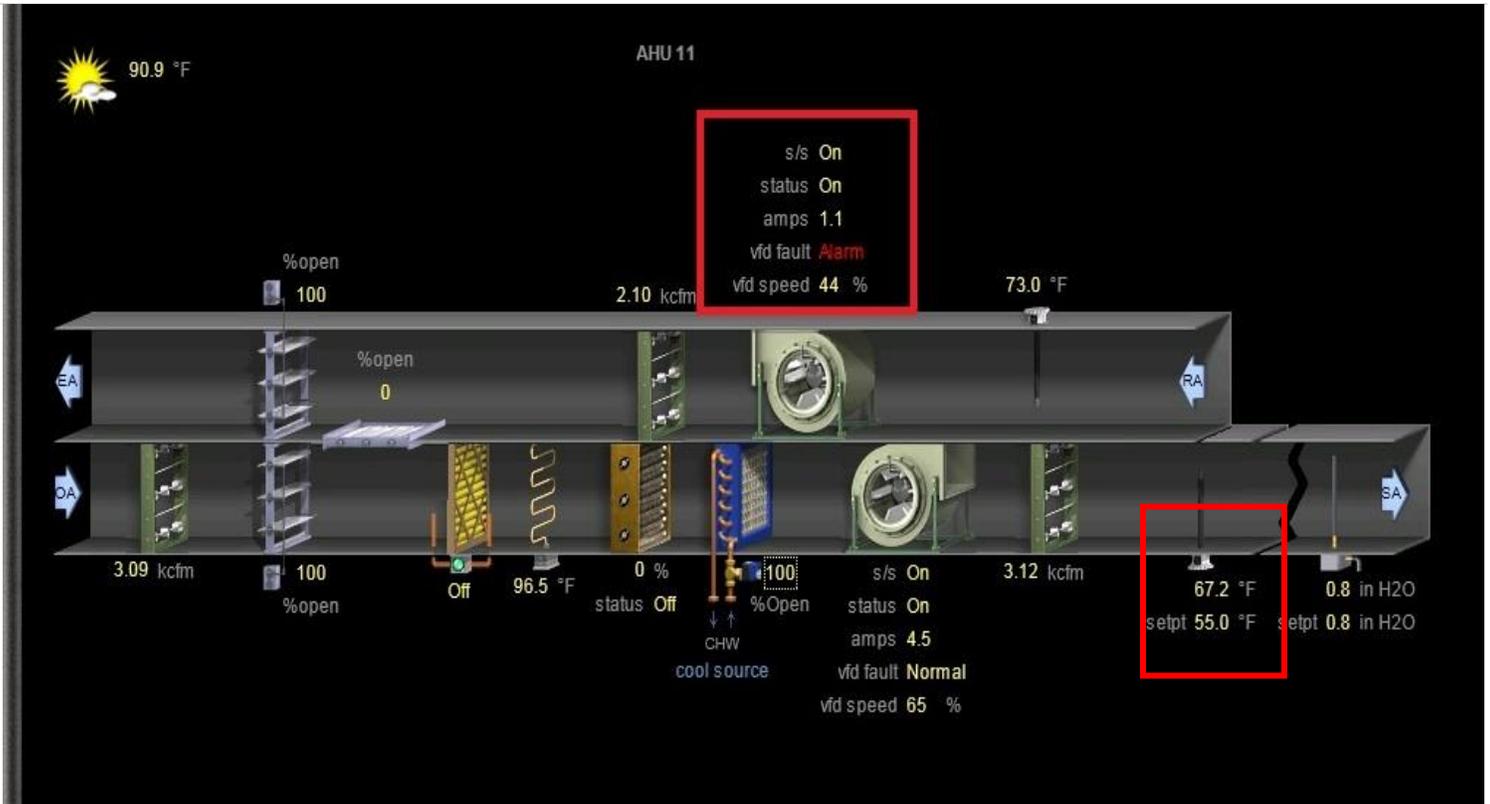
Issue ID #M-107—AHU-11 has an alarm on the return fan VFD. Notice discharge air temperature with CW control valve wide open which is related to the concerns over the chilled water loop temperature.
