# Final Commissioning Report For Eastmont High School

October 2015

# Appendix A – Field & Commissioning Issues Reports

### EASTMONT HIGH SCHOOL COMMISSIONING ISSUES

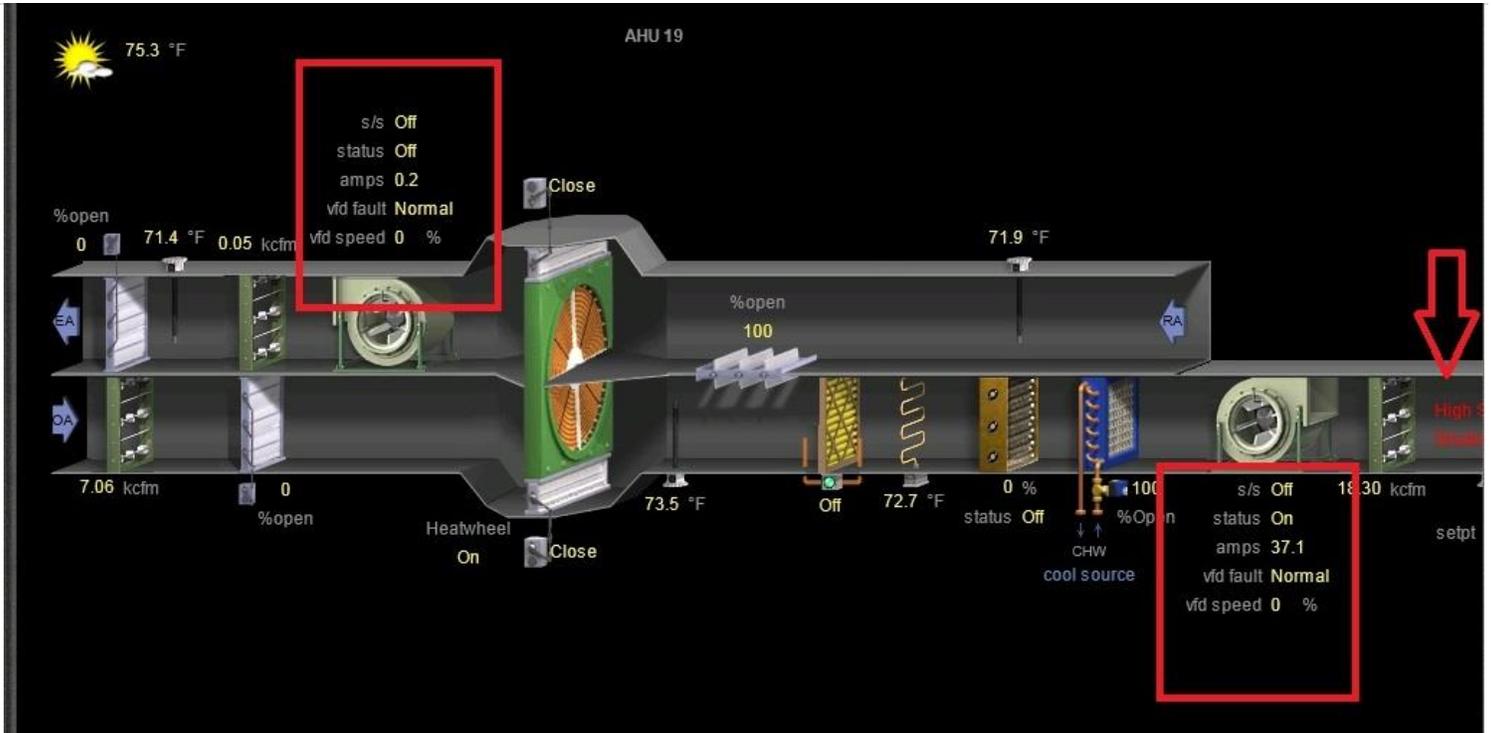
Issue ID #M-108—AHU 19 has failed and there is an unidentifiable alarm indicated towards a portion of the graphic that is not accessible. There is no way to scroll over in order to view it. Contractors should investigate and report back what findings there are prior to additional onsite Cx testing. Graphic should be so that it can be seen in its entirety.

**Parameter download required.**
